Stream Assessment Summary Form (Form 2)

Unified Stream Methodology for use in Virginia

Project #	Applicant	Date
2017-890	Green Ridge Recycling and Disposal Facility	4/11/2022
Evaluators	HUC	Locality
David Kwasniewski, PWD, Kristen Walls, WPIT, Emily Beacham, PE, Eric Myers, Hannah Bullens	02080205	Cumberland Co.

Name(s) of Evaluator(s)	Stream Name and Information
David Kwasniewski, PWD and Eric Myers	Stream Reach 1 - Impact Plate C1.1/Impact 1.1

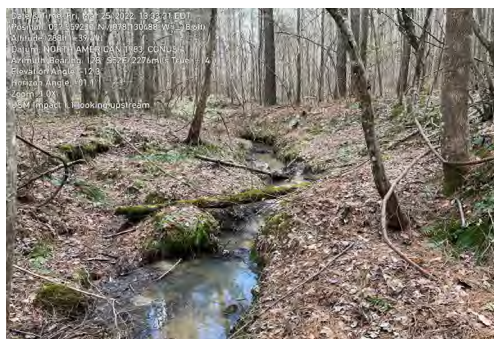
looking upstream

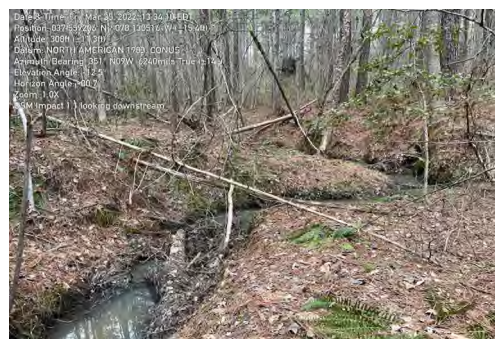
looking downstream

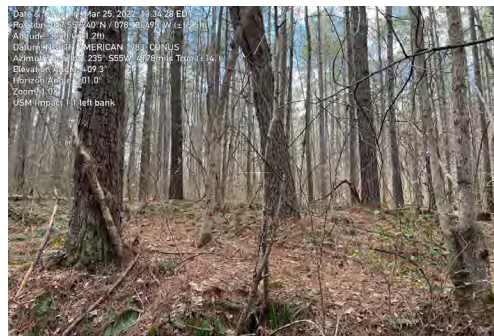
left bank looking downstream

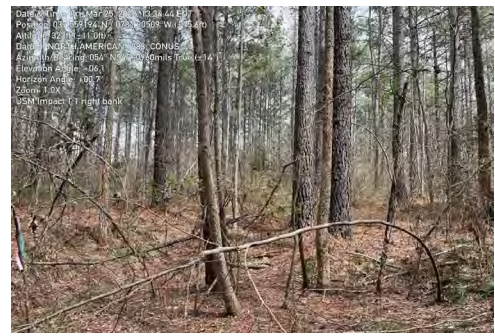
right bank looking downstream

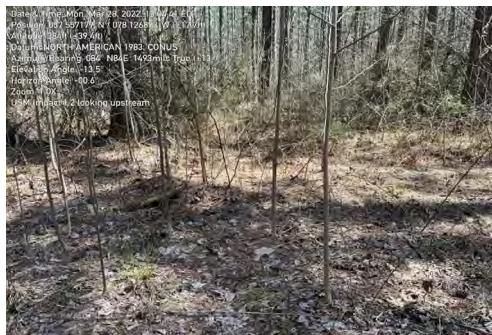
Conditional Category								NOTES>> Channel interrupted by headcut/clearing of relic roadway, historic rutting observed. Holding water - possibly from precipitation.
	Optimal	Suboptimal	Marginal	Poor				
Riparian Buffers	Tree stratum (dbh > 3 inches) present, with > 60% tree canopy cover and an non-maintained understory. Wetlands areas.	High Suboptimal: Riparian areas with tree stratum (dbh > 3 inches) present, with 30% to 60% tree canopy cover and containing both herbaceous and shrub layers or a non-maintained understory.	Low Suboptimal: Riparian areas with tree stratum (dbh > 3 inches) present, with >30% tree canopy cover and a maintained understory. Recent cutover (dense vegetation).	High Marginal: Non-maintained, dense herbaceous vegetation with either a shrub layer or a tree layer (dbh > 3 inches) present, with <30% tree canopy cover.	Low Marginal: Non-maintained, dense herbaceous vegetation, riparian areas lacking shrub and tree stratum, hay production, ponds, open water. If present, tree stratum (dbh > 3 inches) present, with <30% tree canopy cover with maintained understory.	High Poor: Lawns, mowed, and maintained areas, nurseries; no-till cropland; actively grazed pasture, sparsely vegetated non-maintained area, recently seeded and stabilized, or other comparable condition.	Low Poor: Impervious surfaces, mine spoil lands, denuded surfaces, row crops, active feed lots, trails, or other comparable conditions.

looking upstream

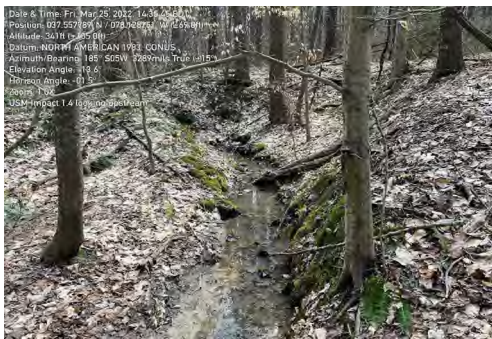
NOTES>>	Several bedrock grade controls observed through the reach. Minimal erosion observed along outer meander.
---------	--

NOTES>> Fluctuations in velocity observed. Woody debris and leaf pack was also observed.

looking upstream

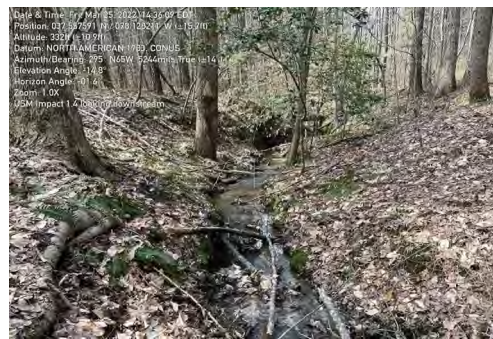
looking downstream

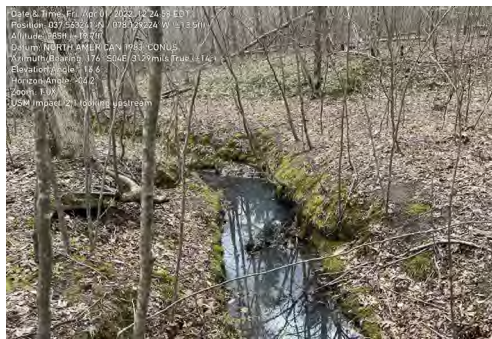
NOTES>> Some erosion on outer meanders. Bedrock as grade control, more cobbles observed than intermittent portion of reach.

NOTES>> Fluctuations in velocity, leaf pack. Woody debris observed, cobbles in riffle.

looking upstream

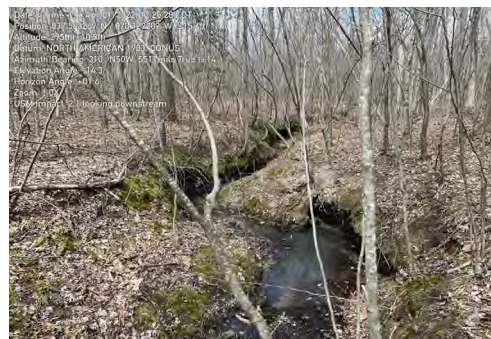
looking downstream

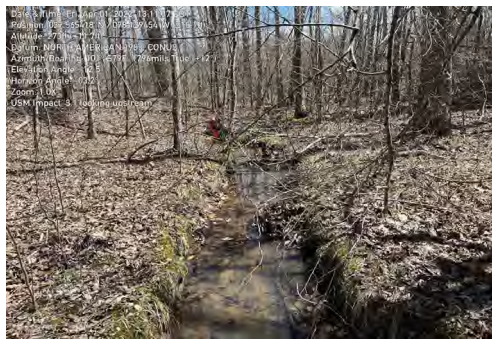
NOTES>>	DS impact of 3.4, channel does not have well-defined bed+bank. Many grade contours observed. Erosion and vertical banks near confluence of 3.4 and US, up to 4 feet vertical banks near confluence with main channel (DS).
---------	--

looking upstream

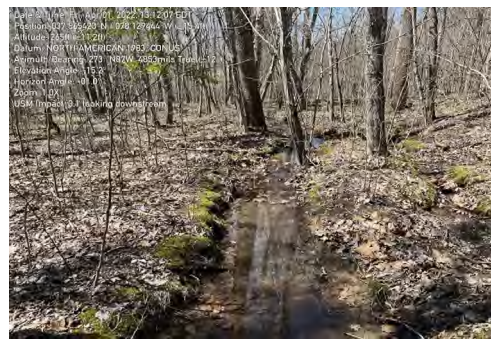
looking downstream
